ecological effects of the Christchurch February earthquake on our city estuary

summary &
management
recommendations

**Environment
Canterbury**
Regional Council
Kaunihera Taiao ki Waitaha

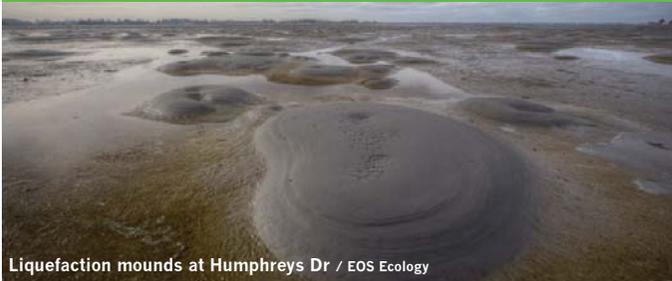
Liquefaction mounds at Humphreys Dr / EOS Ecology

Liquefaction could smother estuarine biota and exhume sediments potentially contaminated with heavy metals, organic matter or nutrients buried under the estuary bed. We examined aerial photographs and measured the location, size and abundance of liquefaction mounds. A startlingly large density of liquefaction mounds was found – ranging from 500–3200 mounds per hectare – greatest at the old city outfall discharge point in the western estuary. The areal coverage was greatest (35–39%) along the eastern part of the estuary (Brighton Spit shore), where mound size also tended to be larger (up to 5 m² per mound). The proportion of the estuary bed covered by liquefaction mounds was substantial (~20–40%) for the sampled areas, and visual inspection of the imagery indicated that this was reasonably representative of the whole estuary.

Transect sampling showed the mounds covered between 30–65% of the estuary surface with the percent cover varying with location within the estuary. Mound height was highly variable, averaging 90–110 cm at two locations and as low as 20 cm at another location. Mound perimeters also varied greatly across sites, averaging 12–13 m, but were smaller at the Discharge and Humphreys sites. The grain size of mound sediment was different to that of the adjacent natural area sediment. Mounds generally had a larger grain size than adjacent natural areas. Mounds were also firmer and composed of coarser material,

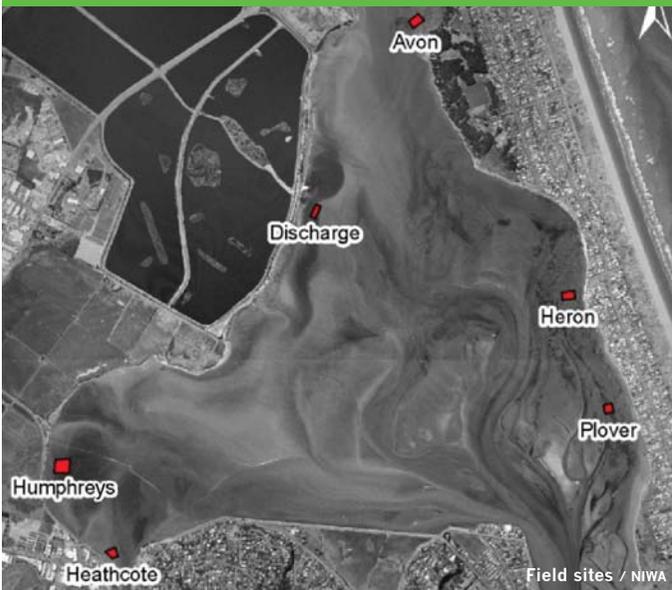
Field sites / NIWA

University of Canterbury researchers undertook field work at six sites in the estuary where they quantified the following:
